Composite Tank Repair

TANK SPOT REPAIR FOR SMALL-DIAMETER OIL & GAS TANKS

MillQuip

Texas

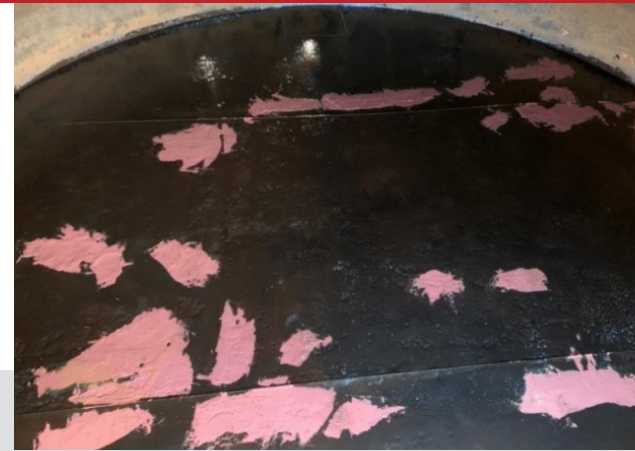
An oil field company acquired seven small-diameter (10 ft) oil tanks from major oil companies. While the tank walls and ceilings were in excellent condition, the tank floors suffered from major corrosion pitting and multiple through-wall failures. If repaired properly, the tanks could be fully operational, as most of the tank structure was still in good working condition. The solution would need to be cost-effective and easy to apply because all seven tanks required attention. The solution would also need to be quick to install and allow for efficient refurbishment to return the tanks to service as soon as possible.

Figure 1 Repair putty filled in pitting

1. Tank floors were first grit blasted to SSPC-SP 6/NACE No. 3 Commercial Blast.
2. The floors were visually inspected, and any holes were marked for repair.
3. Because not all the oil could be removed from the tank floors, an oil-tolerant primer, HP 201 OT, was applied to the tank floor.
4. Depending on the severity of the defects, major concerns were addressed with repair putty or carbon fiber tank repair patches. Repair putty was applied to major corrosion pitting, and carbon fiber was used to address through-wall failures.
5. The tank floors were flood with HP 400-2 Novo, a chemically resistant epoxy novolac coating system, to halt ongoing corrosion and provide a protective barrier.

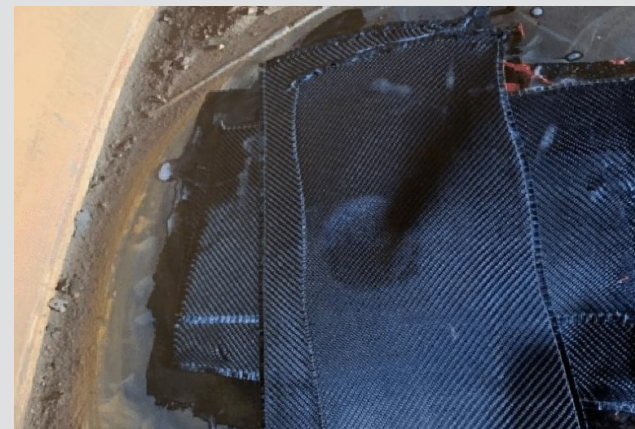
Figure 2 Carbon fiber patches addressed through-wall failures

Advanced FRP Systems recommended using carbon fiber tank patch repairs and a long-lasting coating system to address the tank floor defects.

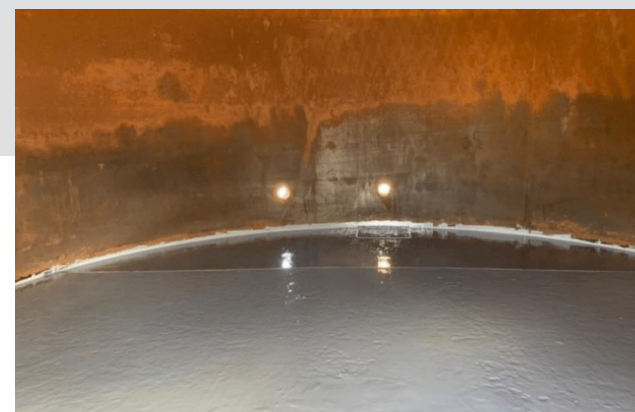
Figure 3 Chemically resistant epoxy novolac coating system
