MUNICIPALITY APPLICATIONS

COMPOSITE PIPE
REPAIR & STRUCTURAL
REINFORCEMENT SHOWCASE

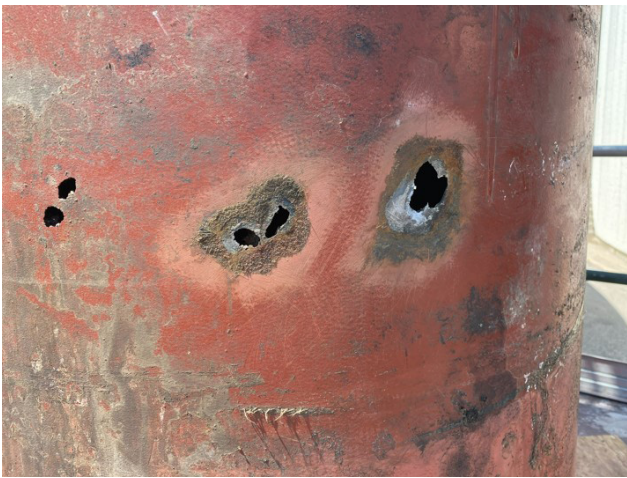
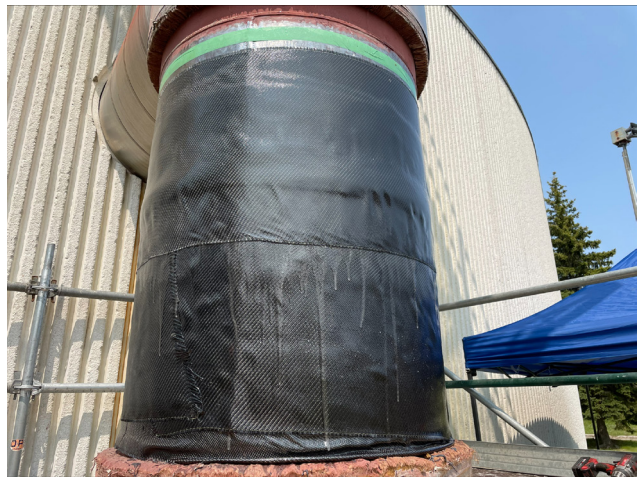
WASTEWATER DRAFT TUBES CARBON FIBER REINFORCEMENT

6-LAYER COMPOSITE WRAP EXTENDS SERVICE LIFE BY SEVERAL YEARS

Significant wear was identified in four of the draft tubes at a wastewater treatment facility. The abrasion was due to internal wear from an agitator in liquid with entrained solids, and the wear bands were roughly two feet long. The facility was looking for a repair that would last several years and be installed on the external surface of the draft tubes.

Advanced FRP's solution first provided a ceramic reinforced epoxy putty to protect against wear. The tubes were then wrapped with 6 layers of high-strength carbon fiber, transitioning at least 18 inches onto sound steel on either side of the wear zone. The finished repair will last several years until a new process is put into place.

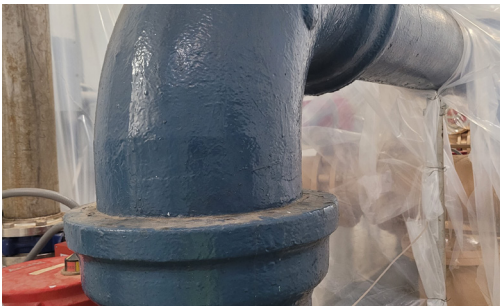
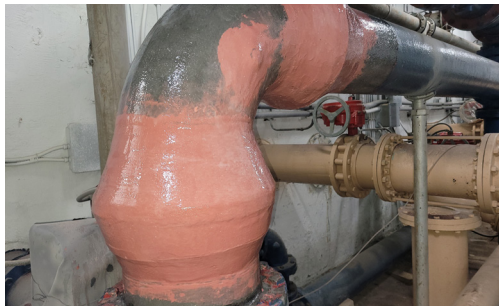
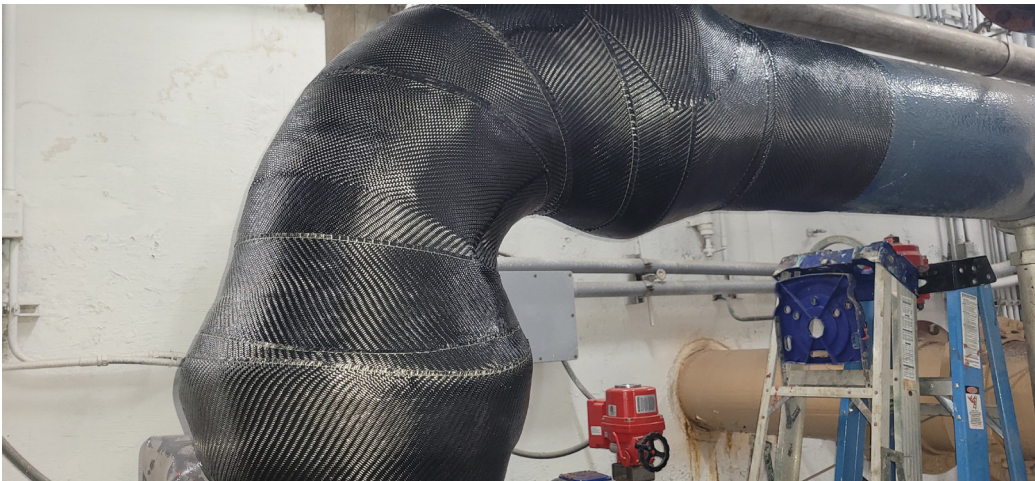
SPIGOT JOINTS AND ELBOW REPAIR

4-LAYER, HIGH-STRENGTH COMPOSITE REPAIR

Inspectors at a water and wastewater facility found corrosion at the spigot joints and elbows of two pipes in a circulating water line. The provided solution started by first blasting the steel surface and then applying a hold

coat. Putty was then used to smooth the surface, transition the joints, and to fill in the pits. A composite system was then applied to complete the pipe reinforcement using a galvanic barrier and 4 layers of carbon fiber.

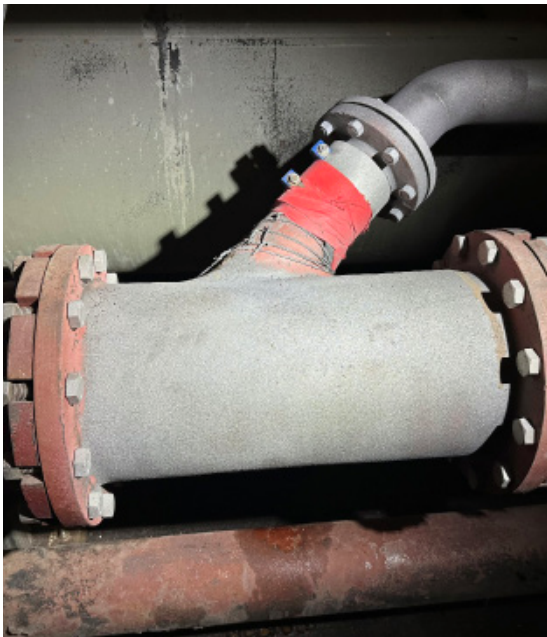
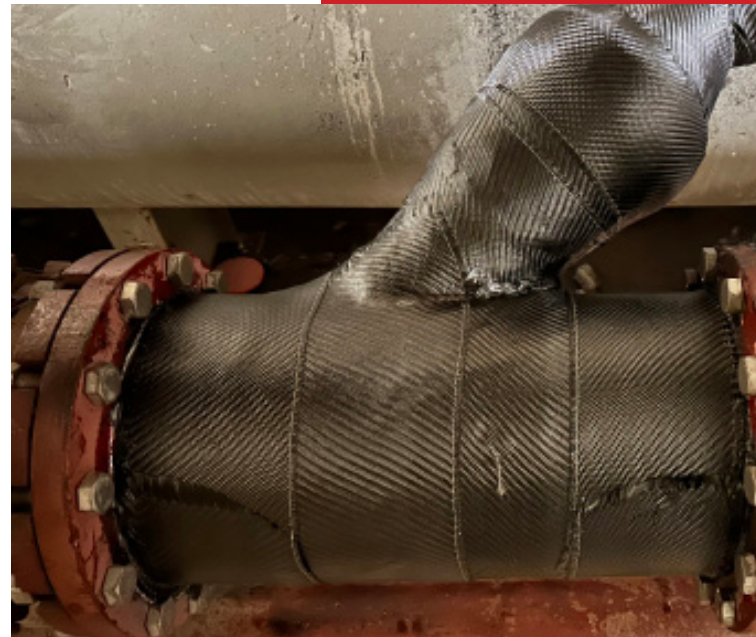
Carbon Fiber Repairs Leak in Mechanical Pipe

PART ONE: LONG-TERM LEAK REPAIR

Employees at a water treatment plant found that a Y-shaped pipe with a mechanical clamp would drip leak when in full service. One requirement of the repair was that the clamp could not be removed for long periods of time.

The applicators began by grit blasting the pipe before applying an adhesive and putty. The pipe was then wrapped in a 6-layer carbon fiber system and reinforced with an epoxy topcoat.

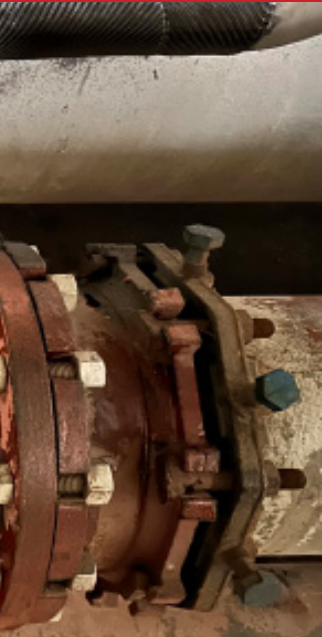
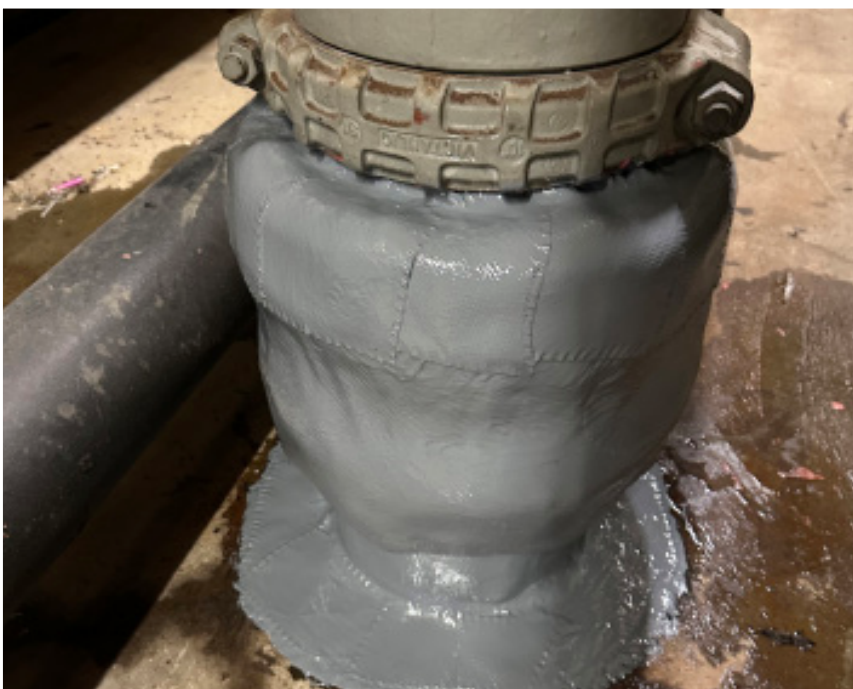
Composite Reinforcement of Pencil-Sized Leak in Pipe

PART TWO: THROUGH-WALL DEFECT REPAIR

The water treatment plant operator also required a repair for a pipe going into a concrete floor with a hole in the side that was approximately the size of a pencil.

The solution required that the applicators first sand blast the pipe before applying an adhesive and putty. A t-miter was then prepared via grinding, and the pipe was wrapped with 6 layers of carbon fiber using a skirt system comprised of small, 12" pieces. The repair area was then covered with an epoxy topcoat.

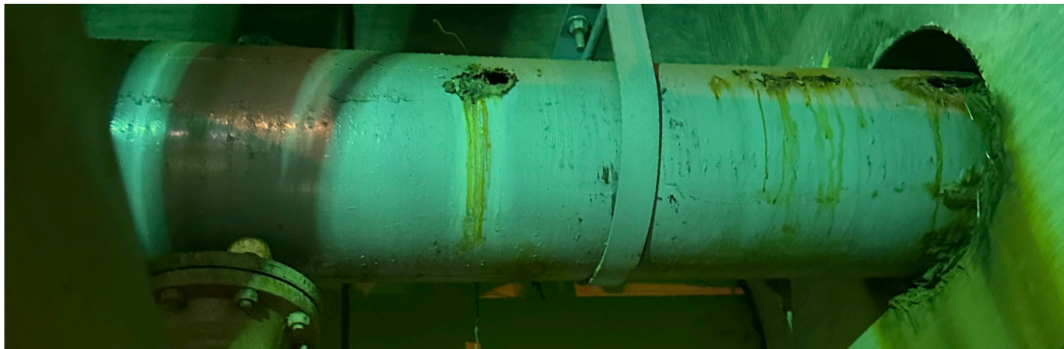
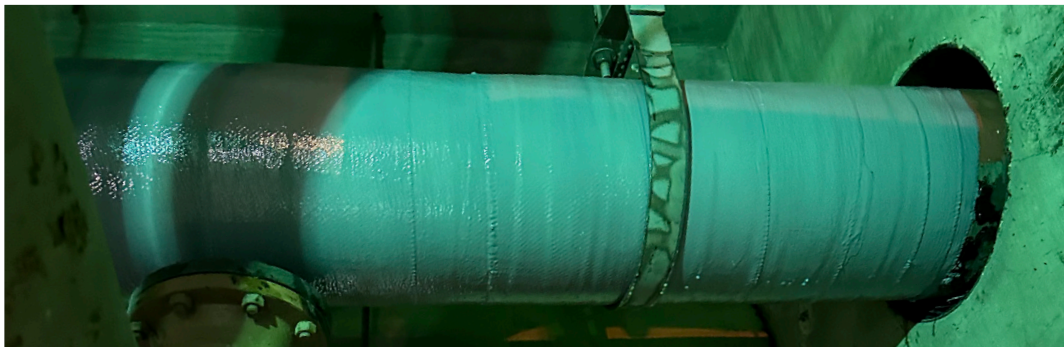
THROUGH-WALL LEAK IN RAINWATER TRANSPORT PIPE

CARBON FIBER REINFORCEMENT OF EXTREME WATER LEAK

A pipe that transported rainwater in the basement of a water treatment plant had a hole going through the side. An employee at the plant stated that when it rained, “it was like a waterfall was coming down in the basement.” The hole was

repaired by first grit blasting the pipe and then applying adhesive and putty. 6 layers of carbon fiber were then wrapped before a topcoat was applied. Six months later, the employee stated that they remain very pleased with the work.

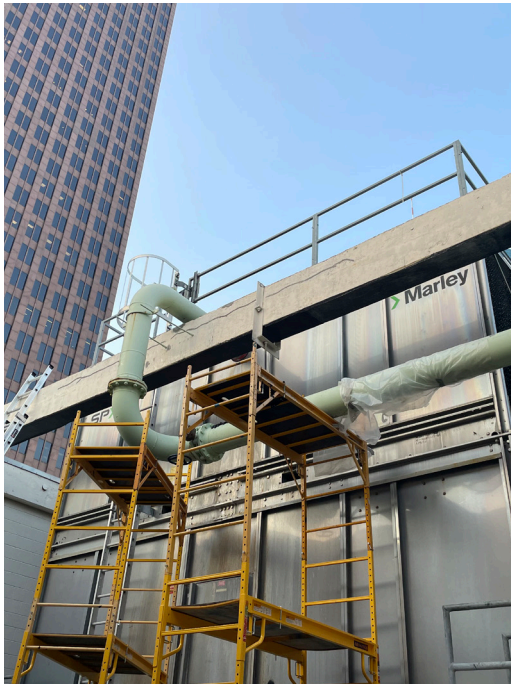
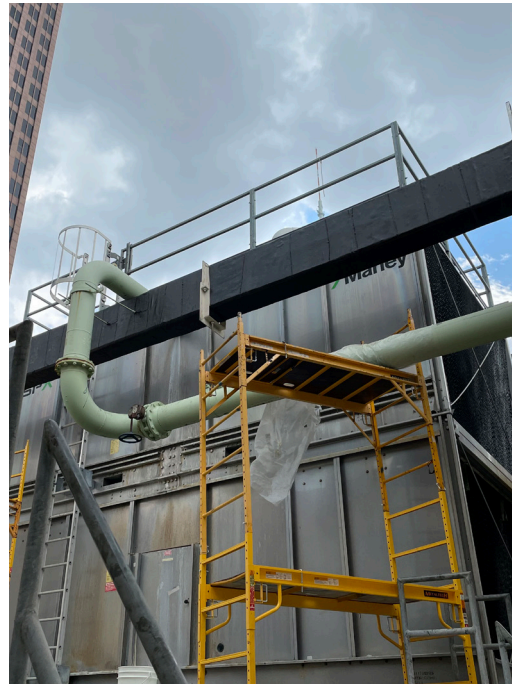
CONCRETE BEAM REINFORCEMENT

BEAM REPAIR AT FEDERAL COURTHOUSE BUILDING

Two concrete beams adjacent to a cooling tower on the federal courthouse building in Houston were cracked and badly degraded from water and wind. A structural engineer determined the correct thickness of carbon fiber to provide the required strength to

withstand the bending movement of the beam. A seven-layer system using a unidirectional carbon fiber composite was applied to the bottom face of the beam. This was then followed by two layers of bi-directional fabric applied in bands around the beam.

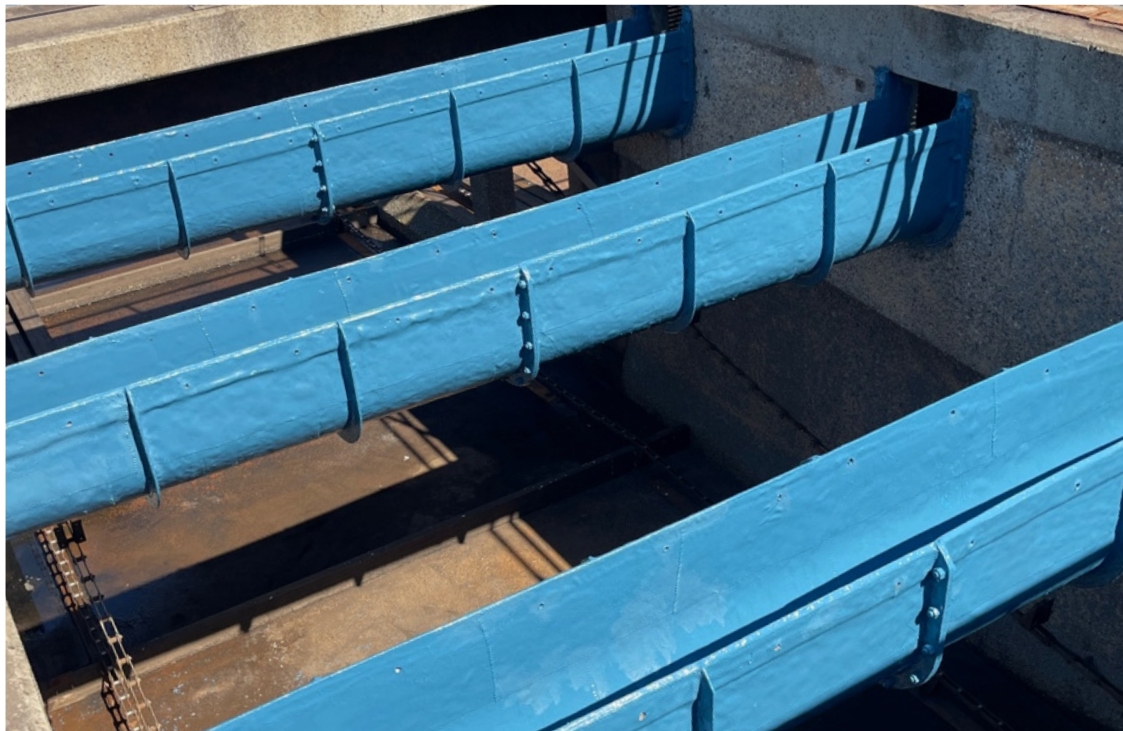
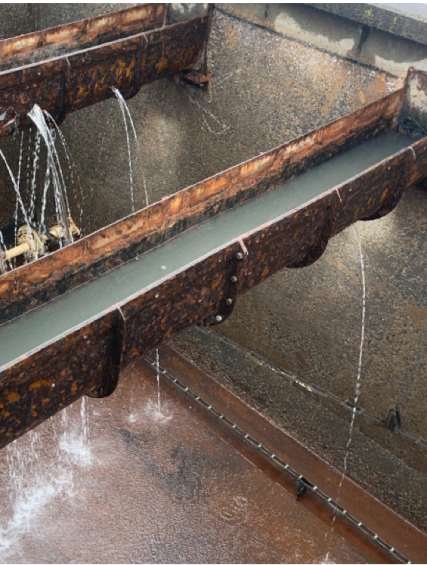
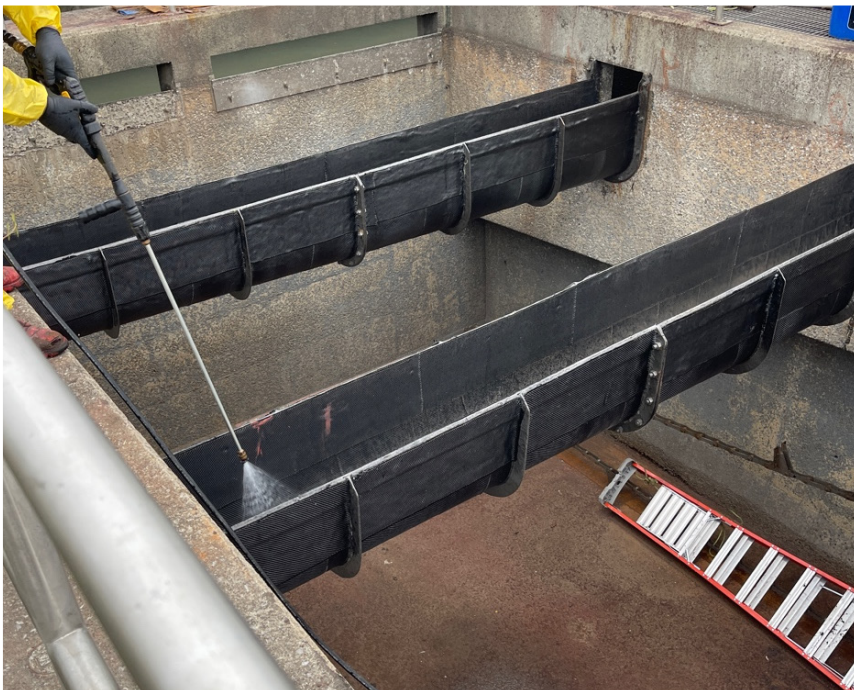
SEVERE CORROSION ON LEVELING TROUGHS

Carbon Fiber Reinforcement Halts Water Level Issues

Inspectors at a water treatment plant found that six leveling troughs had severe corrosion that was causing water level issues. The solution required that the troughs first be completely drained before they were power-washed and sand blasted.

COMPLETE RESTORATION ACHIEVED

The troughs were wrapped in a 4-layer carbon fiber system on the inside and outside. A corrosive resistant topcoat was then applied to the repair area.
