MUNICIPALITY APPLICATIONS

COMPOSITE PIPE
REPAIR & STRUCTURAL
REINFORCEMENT SHOWCASE

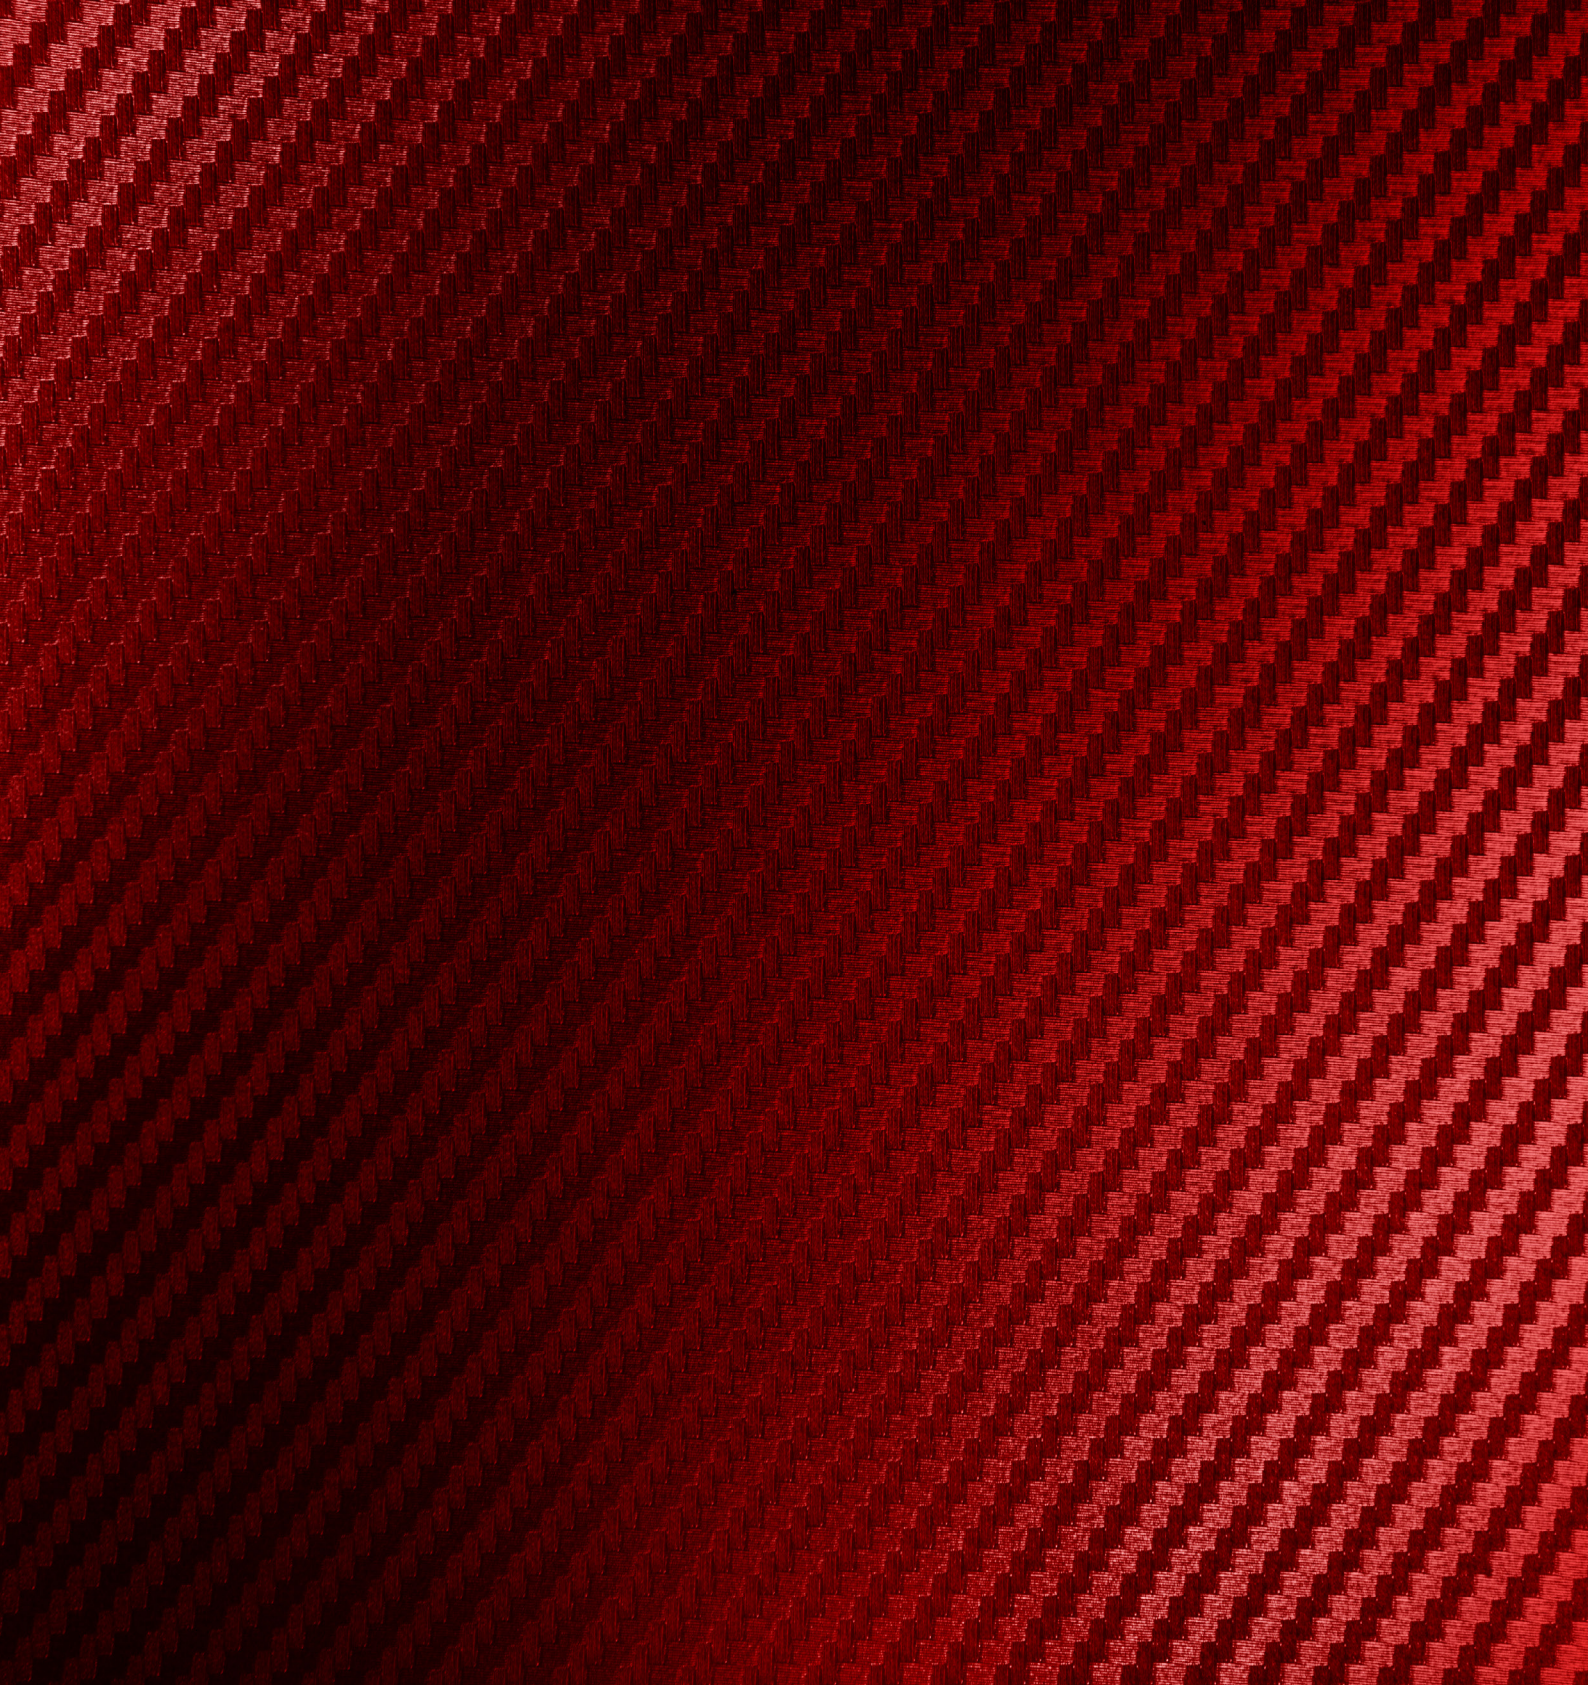
Inspectors at a water treatment plant found that six leveling troughs had severe corrosion that was causing water level issues. The solution required that the troughs first be completely drained before they were power-washed and sand blasted.

The troughs were wrapped in a 4-layer carbon fiber system on the inside and outside. A corrosive resistant topcoat was then applied to the repair area.
